ISSUED FOR CONSTRUCTION

EDM-KOA-D-VOR-C003.DGN

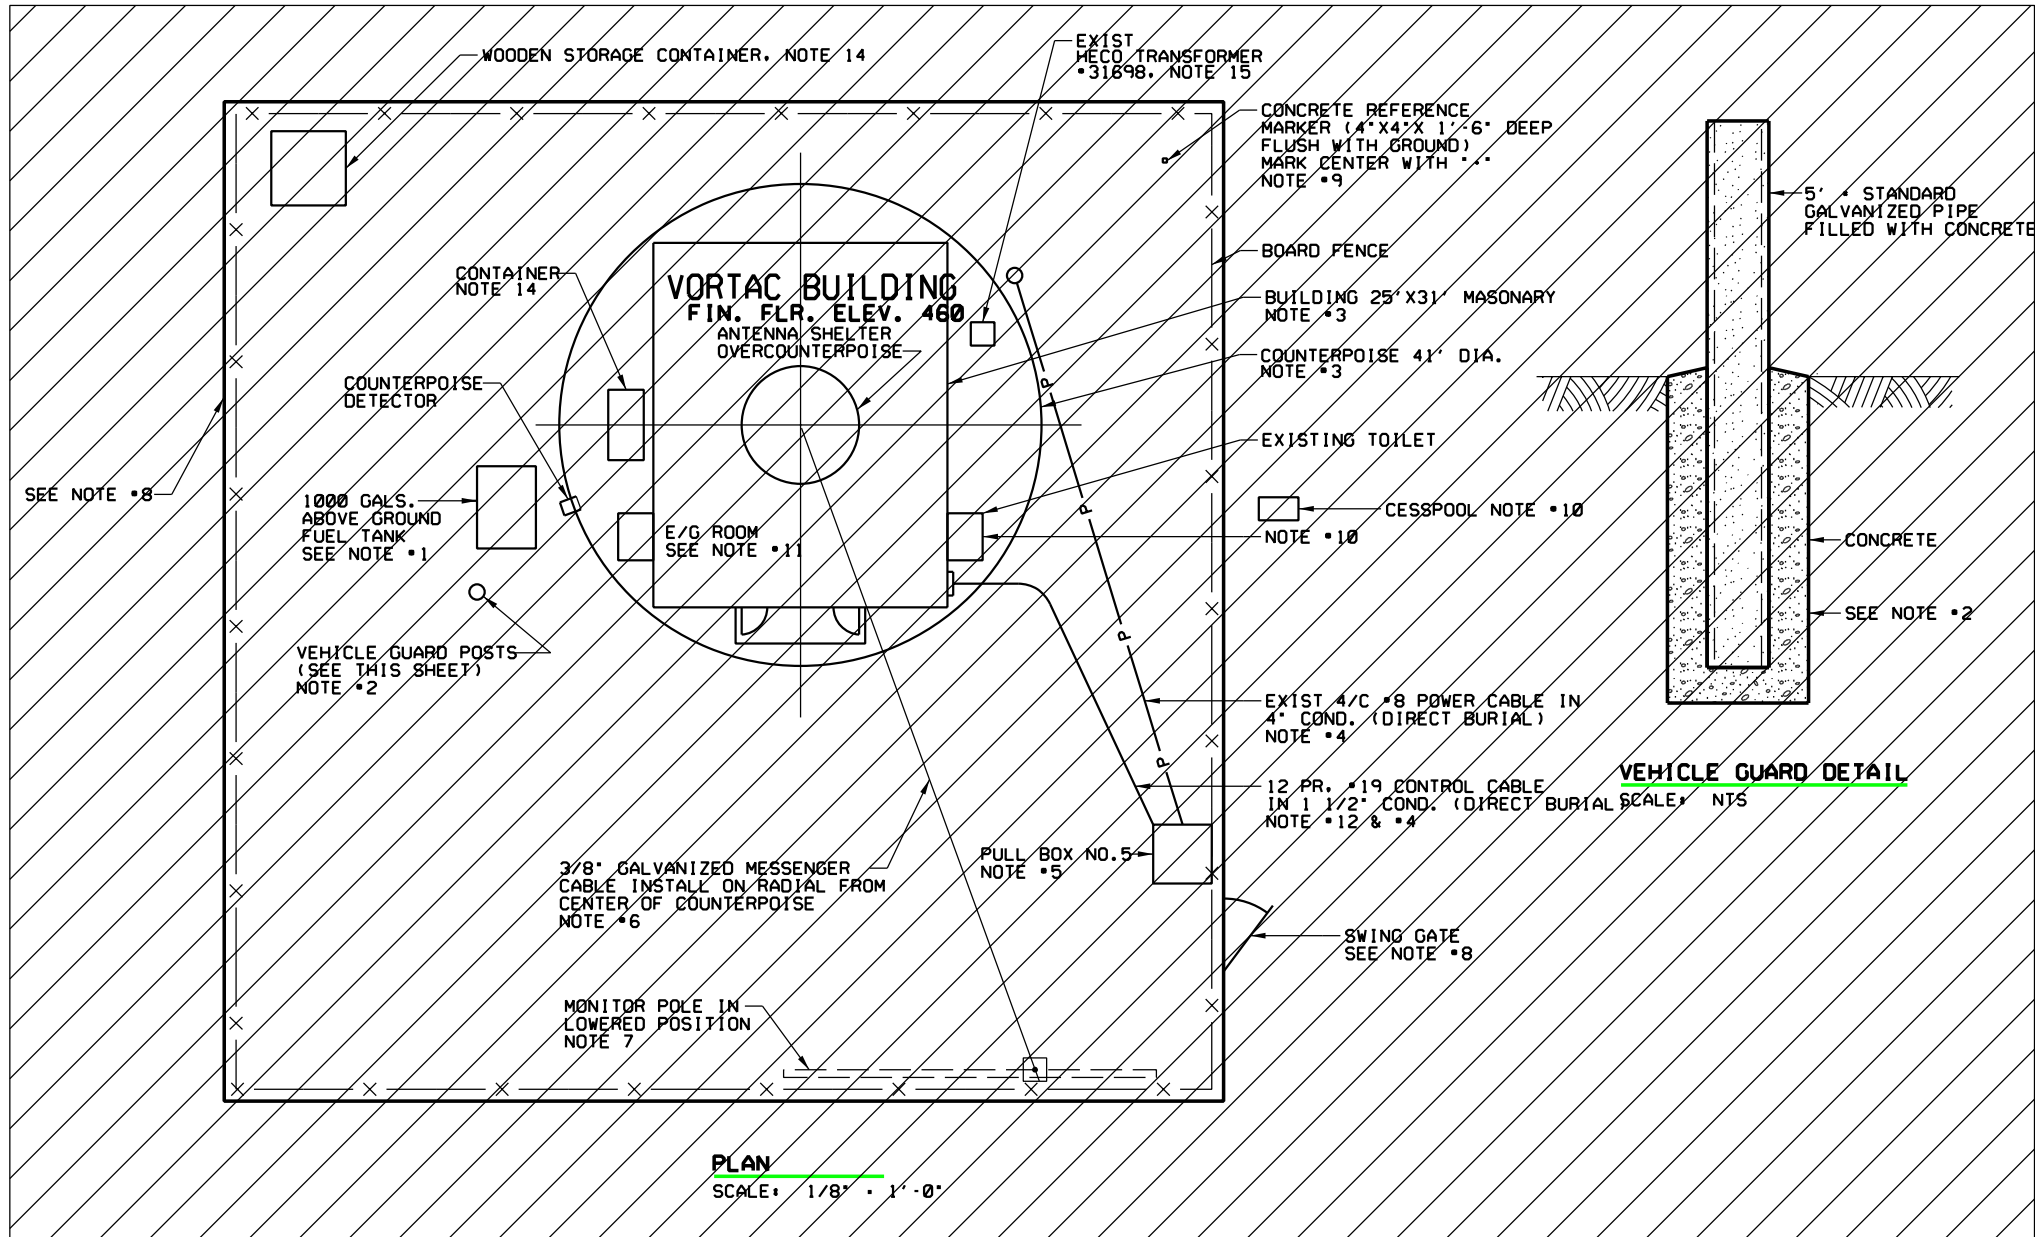
1. EMPTY EXISTING 1000 GAL DIESEL FUEL. REMOVE CONVALT FUEL TANK, CRATE AND TRANSPORT TO A LOCATION DESINGATED BY THE FAA SSC MANAGER. DEMOLISH EXISTING CONCRETE PAD TO EXISTING GRADE LEVEL

2. DEMOLISH EXISTING CONCRETE FILLED VEHICLE GUARD POLES.
3. DEMOLISH EXISTING MASONARY VORTAC BUILDING AND COUNTERPOISE ROOF TO GRADE LEVEL. HAUL AWAY RUBBISH FROM THE SITE AND RE-GRADE TO EXISTING CONDITION.

4. REMOVE EXISTING POWER AND HECO CABLES. TO THE LAST POWER POLE ABOUT 1000' AWAY FROM SITE AND ABANDON CONDUITS.
5. REMOVE EXISTING PULL BOX LOCATED INSIDE THE FENCE AREA.

6. REMOVE EXISTING MESSENGER CABLE
7. REMOVE EXISTING MONITOR ANTENNA POLE AND FOUNDATION.
8. REMOVE EXISTING BOARD FENCE AND SWING GATE.
9. REMOVE EXISTING CONCRETE REFERENCE MARKER.

10. REMOVE EXISTING TOILET ENCLOSURE AND CESSPOOL LOCATED OUTSIDE THE BOARD FENCE.
11. REMOVE EXISTING EXISTING ENGINE GENERATOR, TRANSFER SWITCH, DAY TANK, MUFFER, BATTERY RACK, LOAD BANG AND OTHER ASSOCIATED HARDWARE. CONTRACTOR SHALL CRATE THE UNIT AND TRANSPORT TO A DESIGNATED LOCATION IDENTIFIED BY LOCAL SSC MANAGER. DISPOSE BATTERIES IN PROPER PROCEDURE.

12. REMOVE EXISTING COMMUNICATION CABLES AND ABANDON CONDUITS.
13. HAUL AWAY ALL DEBRIS AND CLEAN UP PREMISES TO GOOD CONDITION AND TO SATISFACTION OF RESIDENT ENGINEER.

14. REMOVE & DISPOSE TWO (2) CONTAINERS.
15. CONTRACTOR SHALL COORDINATE WITH HECO TO TURN THE POWER OFF AND REMOVE THE TRANSFORMER.
